Breakage of the tip of a flipcutter during ACL reconstruction: A rare complication of the knee arthroscopy

We report a case of broken tip of the reprocessed flipcutter guide pin (arthrex, Naples, FL) while drilling the tibial socket for the ACL reconstruction. The complication was identified immediately and the broken instrument removed piece meal. We have not come across such a case in the literature and it is the first report of its kind to our knowledge. Repeated use of flip cutter is to be avoided to prevent such hazards. Also care should be taken to lock the blades properly before starting to drill the sockets. Although instrument breakage is a rare complication during knee arthroscopy, orthopaedic surgeon should be aware of this complication and methods to deal with it.

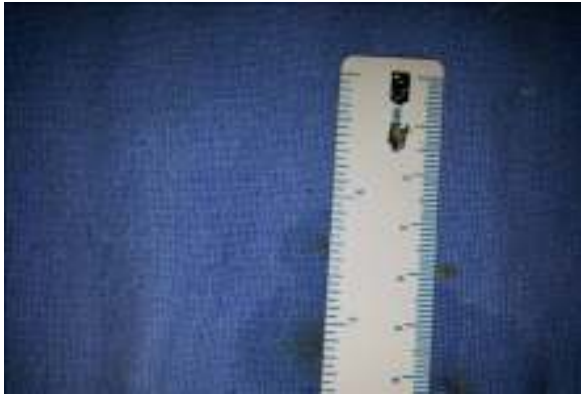
Figure 1: The broken blades of the flipcutter

A 18 year old patient had suffered an injury to the right knee and presented to us with knee instability. Clinically and radiologically he had complete disruption of the ACL. So he was considered for the ACL reconstruction using a single bundle quadrupled semitendinosus graft. After initial diagnostic arthroscopy semitendinosus was harvested with mini incision technique. The graft was prepared and augmented with fiber tape and tightrope. While drilling tibial socket the flipcutter's blades broke. It was identified immediately and the flipcutter was advanced into the knee joint antegradely. The twisted blades were caught using a long artery forceps and removed piece meal through the antero medial portal. The remaining tip of flip cutter was straightened by compressing its end. It was removed carefully by retrograde drilling and inspected for its completeness.

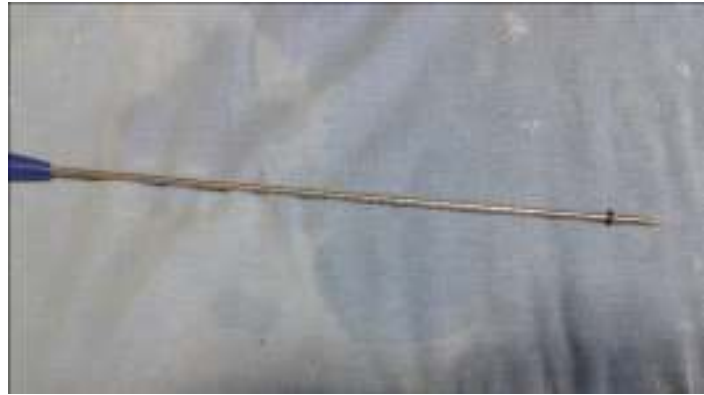
Figure 2: The shaft of the flipcutter whose tip is cut for the safe removal of the guide
