Breakage of the tip of a flipcutter during ACL reconstruction: A rare complication of the knee arthroscopy

We report a case of broken tip of the reprocessed flipcutter guide pin (arthrex, Naples, FL) while drilling the tibial socket for the ACL reconstruction. The complication was identified immediately and the broken instrument removed piece meal. We have not come across such a case in the literature and it is the first report of its kind to our knowledge. Repeated use of flip cutter is to be avoided to prevent such hazards. Also care should be taken to lock the blades properly before starting to drill the sockets. Although instrument breakage is a rare complication during knee arthroscopy, orthopaedic surgeon should be aware of this complication and methods to deal with it.

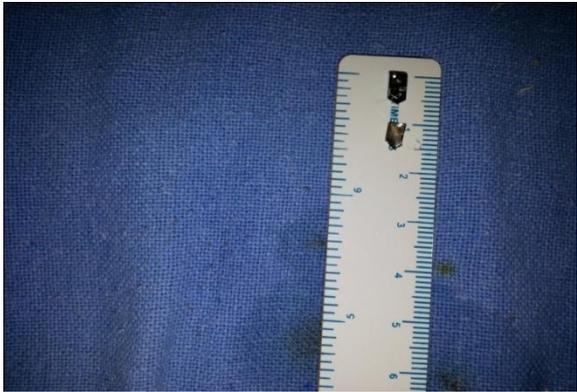
Figure 1: The broken blades of the flipcutter

A18 year old patient had suffered an injury to the right knee and presented to us with knee instability. Clinically and radiologically he had complete disruption of the ACL. So he was considered for the ACL reconstruction using a single bundle quadrupled semitendinosus graft. After initial diagnostic arthroscopy semitendinosus was harvested with mini incision technique. The graft was prepared and augmented with fiber tape and tightrope. While drilling tibial socket the flipcutter's blades broke. It was identified immediately and the flipcutter was advanced into the knee joint antegradely. The twisted blades were caught using a long artery forceps and removed piece meal through the antero medial portal. The remaining tip of flip cutter was straightened by compressing its end. It was removed carefully by retrograde drilling and inspected for its completeness.

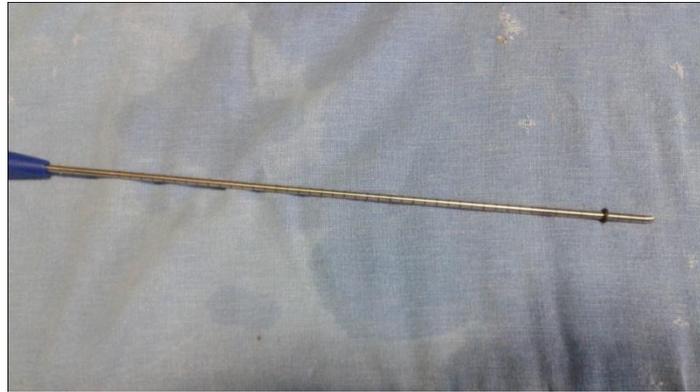
Figure 2: The shaft of the flipcutter whose tip is cut for the safe removal of the guide
